TERMS OF REFERENCE (ToR)

FEASIBILITY STUDY FOR THE REHABILITATION/CONSTRUCTION OF TWO DAMS

Kerfu Dam Rehabilitation Feasibility Report

Meski Ebeid Embankment Dam Feasibility Report

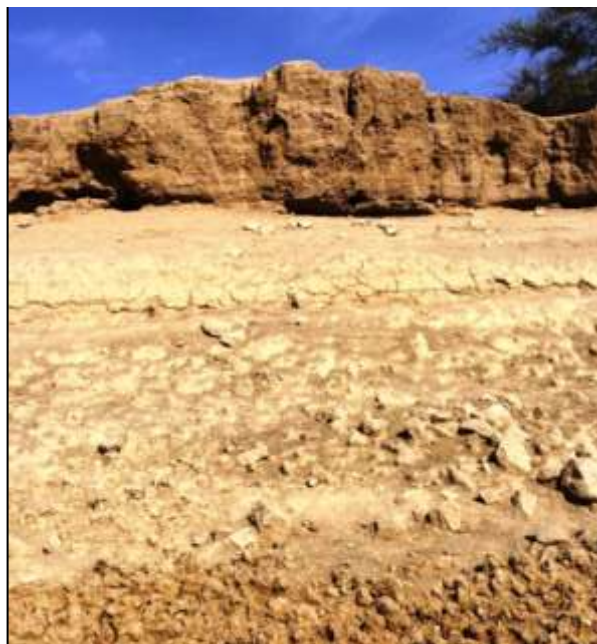
According to village elders at Orshi the embankment dam was constructed in 1968 but 11 years after being commissioned it was breached in 1979. Some years after the embankment was breached the local community constructed a small embankment near to 'watershed 2' in an attempt to store some surface water presumably to compensate for the loss of the water storage caused by the embankment breach.

The photograph below shows the breach in the embankment taken from a low point in the *wadi*.

In addition the width of the breach was measured at 45m.

It appears technically possible to repair the breach and at the same time increase the maximum water depth.

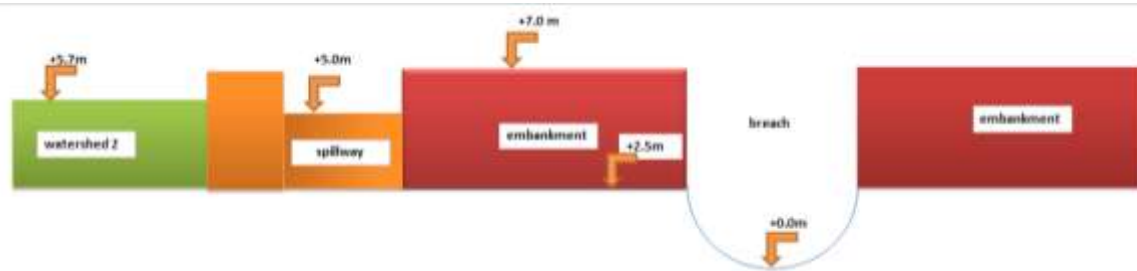
The information presented in the above table is now presented below as a schematic.

The interesting aspect of the survey work is that it appears that the elevation of 'watershed 2' is only 700mm higher than the spillway crest. This means that once the water depth at the spillway crest is greater than 700mm water will start to bypass the embankment by flowing over 'watershed 2'. In affect the embankment has two spillways, the concrete which starts to discharge when the water is 2.0m below the top of the embankment and a natural spillway ('watershed 2') which functions when the water level is 1.3m below the top of embankment.

The spillway crest was found to be 2m below the top of the embankment. The spillway width was measured and found to be 16.85m. Assuming that 1m is kept as a freeboard this means that the discharge rate through the spillway crest can be a maximum of 26m³/s.

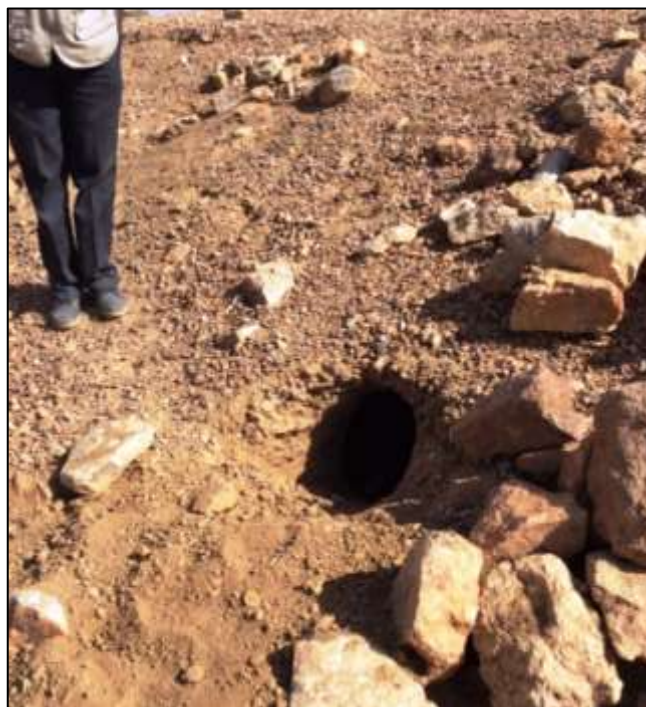
During the inspection of the embankment in 2017 burrows were observed in the downstream batter slope of the embankment. These burrows are very big and thought to be possibly the work of anteaters. If any seepage from the upstream batter slope found its way into the burrow it would quickly lead to 'piping' which would create a breach in the embankment.

The photograph below (taken in 2017) is of an animal burrow in the actual embankment at Kerfu.

It is very difficult to know for certain what caused the embankment to fail in 1979 but the finger points towards poor maintenance such as letting animals making burrows in the embankment.

While it is not known if these burrows are present at the time of the embankment being breached they certainly need to be removed and the void repaired during any rehabilitation. Also the community must be informed of the dangers of allowing animals to establish burrows in the embankment.

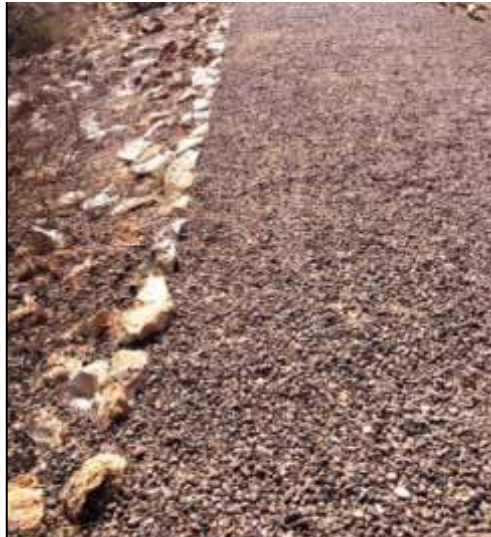
On inspection of Kerfu it's clear the standard of construction and level of supervision was very high. The embankment, constructed almost 50 years ago, is still in a good condition as evidenced by the photograph (below) taken in 2017. Also of note is that there is no evidence of over-topping on the remaining section of the embankment – the gravel on the top is still in place.

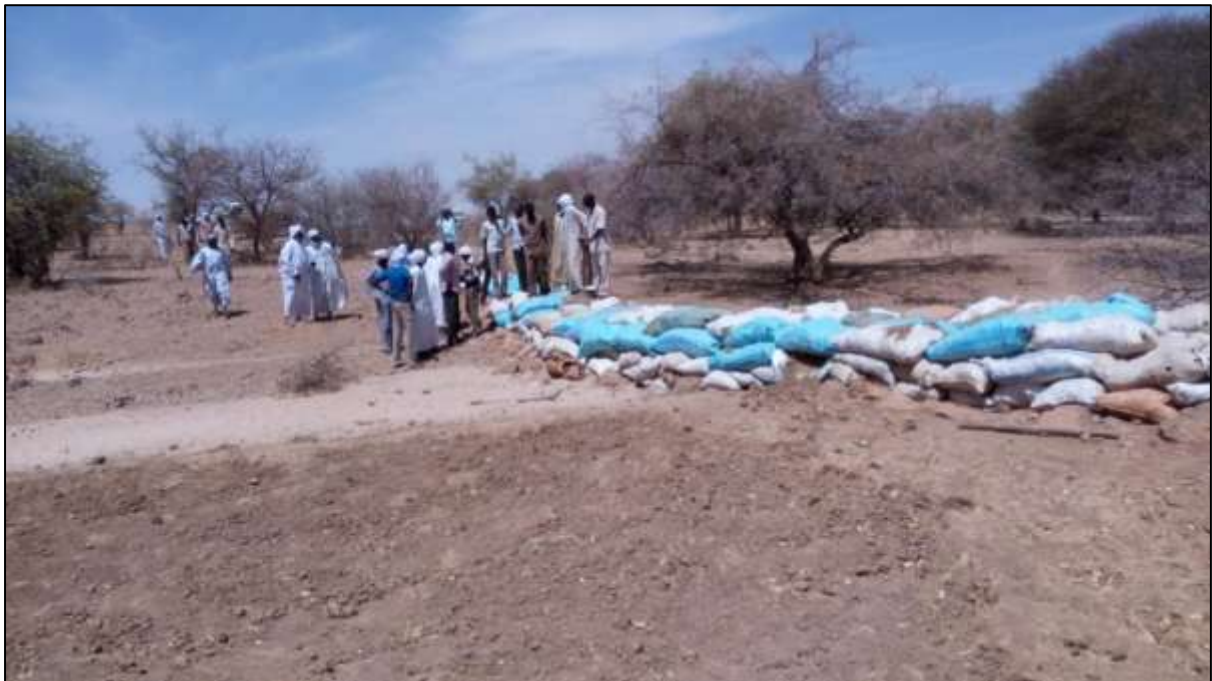
Water is scarce at Meski Ebeid and presently people have no irrigation options outside of the rainy season. The community have recently tried to construct a small dam wall (see photo below taken in 2016) but it failed to hold water due to technical reasons and when inspect in 2017 it had been badly damaged during the rainy season.
